Ramsey Churchyard

Ivy removal trials 17-19 March 2008

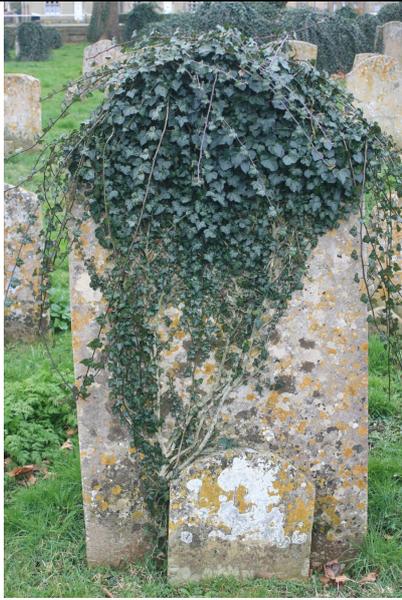
Photograph 1: **Juvenile**

- **Juvenile** - stones with young growth/s of ivy growing up one or both sides, but where the individual ivy stems are very clear and a large proportion of the gravestone is visible.
- **Shroud** – stones which are completely covered with ivy, with very little, if any, stone showing on either side and ivy growths cascading down from the top increasing the thickness of the cover, but no flowering/arboreal growth present.
- **Shrub** – stones as above, but where the woody flowering stems of ivy have been produced over the whole structure, from ground level up to and above the top of the stone.
- **Shrub & Shroud** – similar to ‘shroud’ but where the woody flowering stems have been produced at the top of the stone only, not all the way down to the ground.

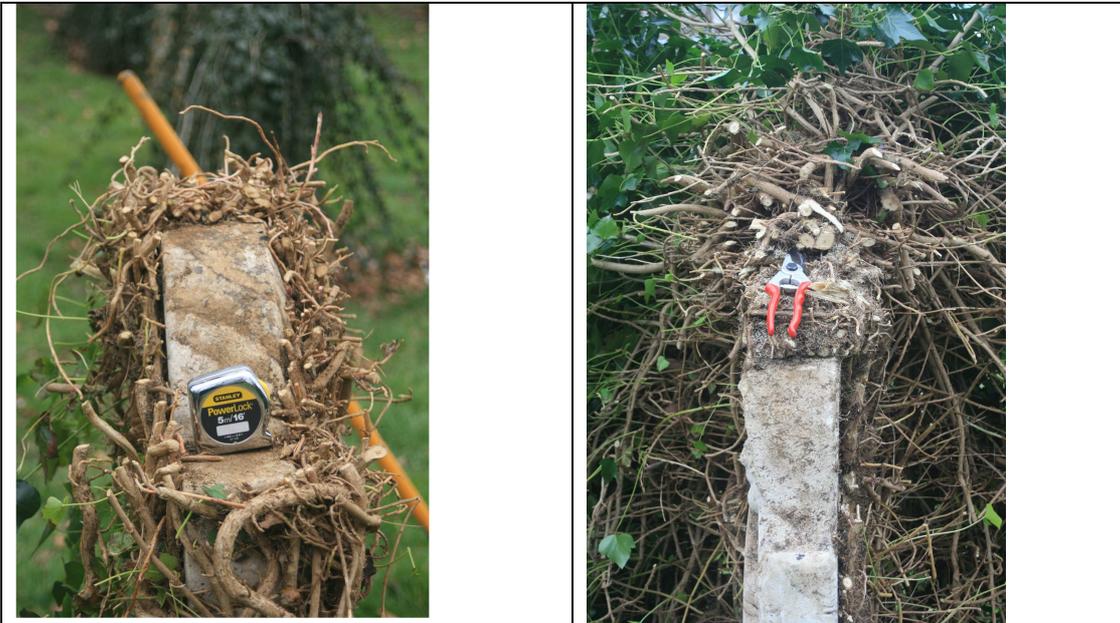
needs particularly careful attention for two reasons; firstly the tops were all heavily covered with numerous overlapping stems and care needs to be taken to ensure saws do not cut into the gravestone. Secondly, the tops of stones may be of different forms, with stepped details, carved swirls and possibly ornate finials or similar and great care needs to be taken to prevent damage to these when pulling stems off (see photographs 5 & 6 below). The simplest way to tackle these was to remove stem sections individually rather than trying to peel off great chunks.

Photographs 5 & 6 : care needs to be exercised at the top of stones to protect detailing

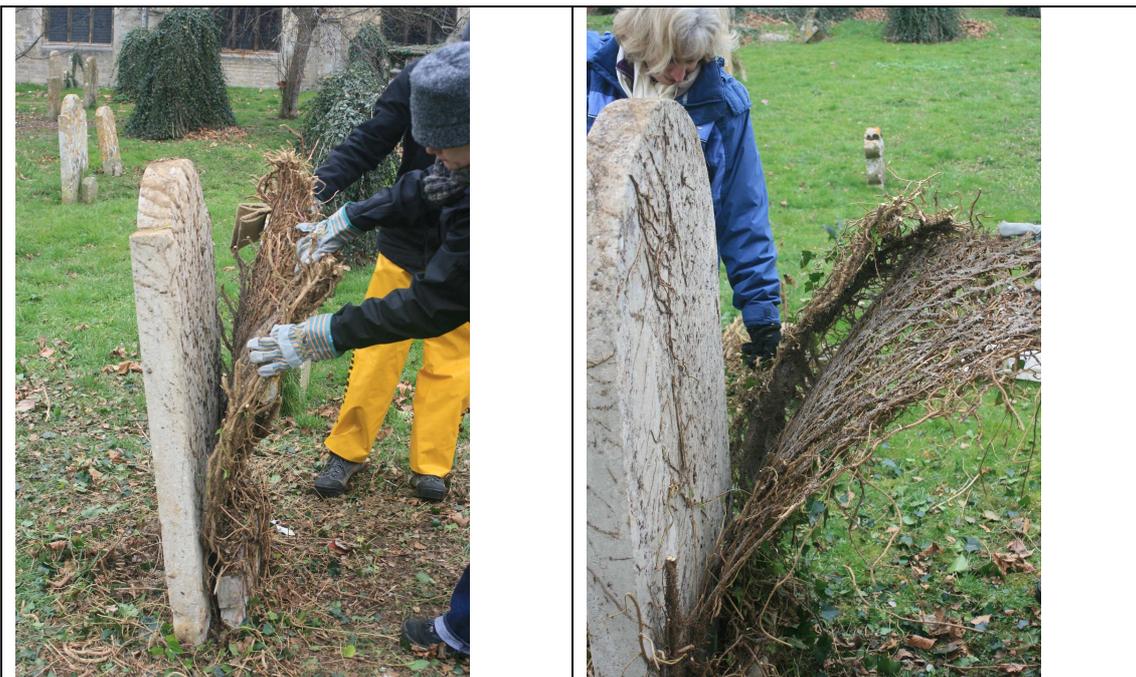
Once the top has been cleared the stems running down the sides can be cut and in all cases the rest of the framework proved surprisingly easily to simple peel away from the face of the gravestone (see Photographs 7 & 8 below).

Photographs 7 & 8 : Older stems proved remarkably easy to peel away once the outer growth had been removed

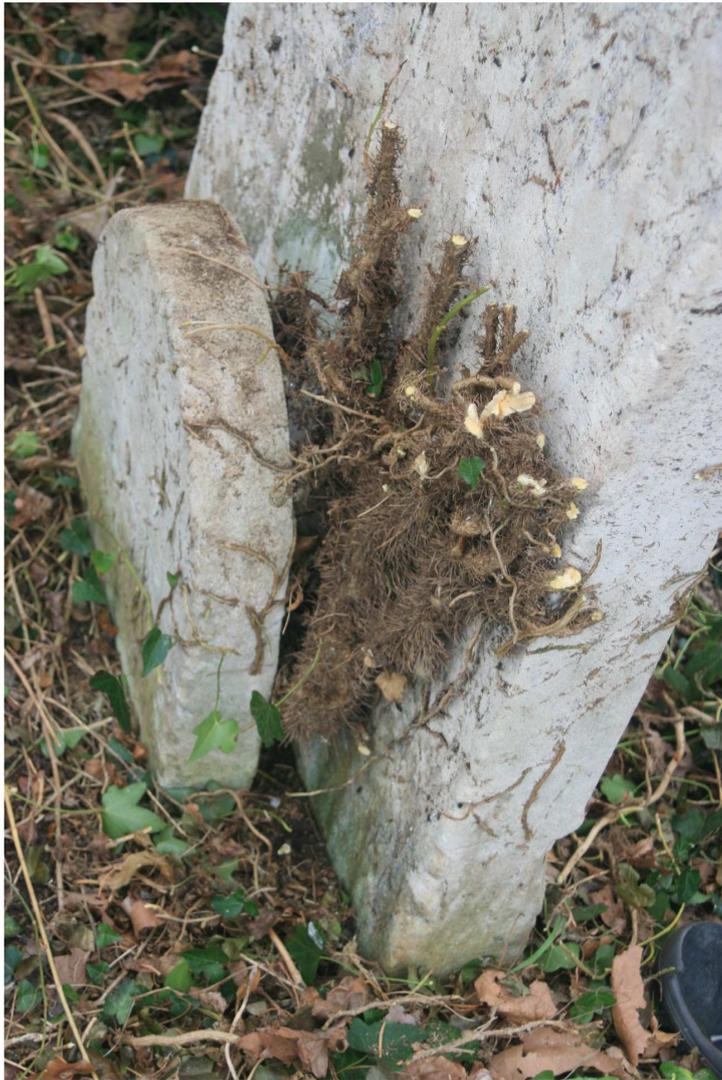
Photograph 9 : many stems become established between the main gravestone and adjacent ‘footstone’

When this is done the main stump and roots can often be either completely pulled up, or pulled up sufficiently to cut the main roots some way along their length. If this is achieved further growth should be prevented because ivy does not regenerate from roots. Where the ivy cannot be removed with the majority of its roots, either because the ground disturbance would be too great or the stump is inaccessible – for instance wedged between the main gravestone and the smaller ‘footstone’ (see photograph 9) – which seems to be a frequent occurrence – the main stem should be cut as low as possible and the remaining stump treated with an appropriate chemical to prevent regrowth (e.g. Triclopyr) or any subsequent regrowth removed before it can properly establish.

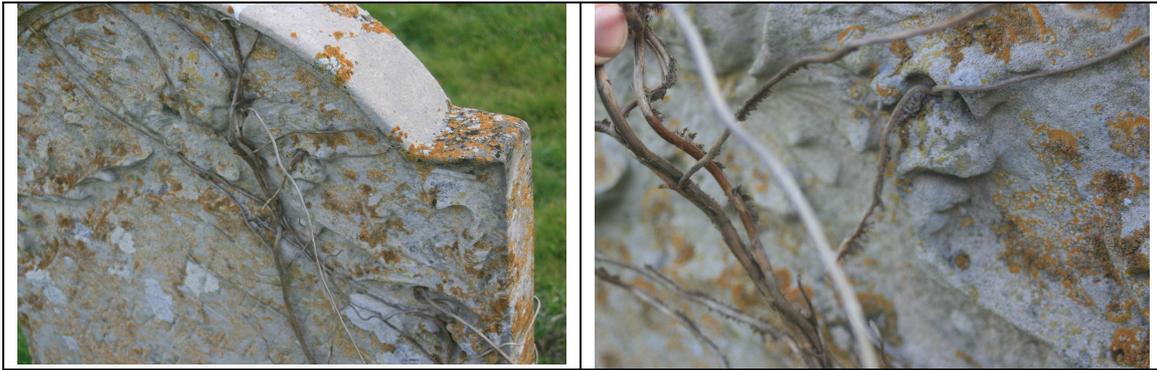
Interestingly, juvenile stems were found to be much harder to remove than the much older stems. When dealing with these stems it is probably best to remove the basal section (and root) and leave the remainder to completely die, after which removal will be easier (see photographs 10 & 11 below). This method will work well for gravestones, where there is no possibility of the stems rooting into the structure, but should be used with great caution if dealing with walls or monuments where rooting into the structure is possible.

Photograph; 10 & 11 : Completely dead young stems of ivy can be removed easily

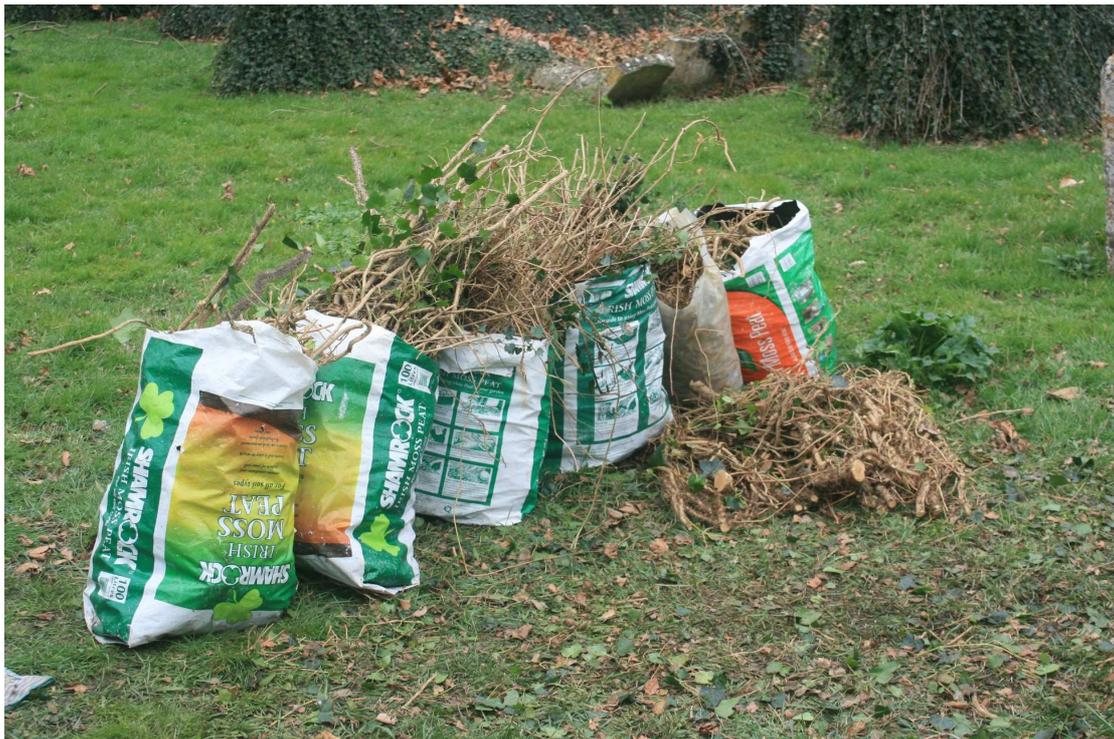
Prepare for a large amount of waste – each of the gravestones cleared produced over 6 large sacks of arisings (see photo 12).

Photograph 12: The arisings from one gravestone cleared of ivy

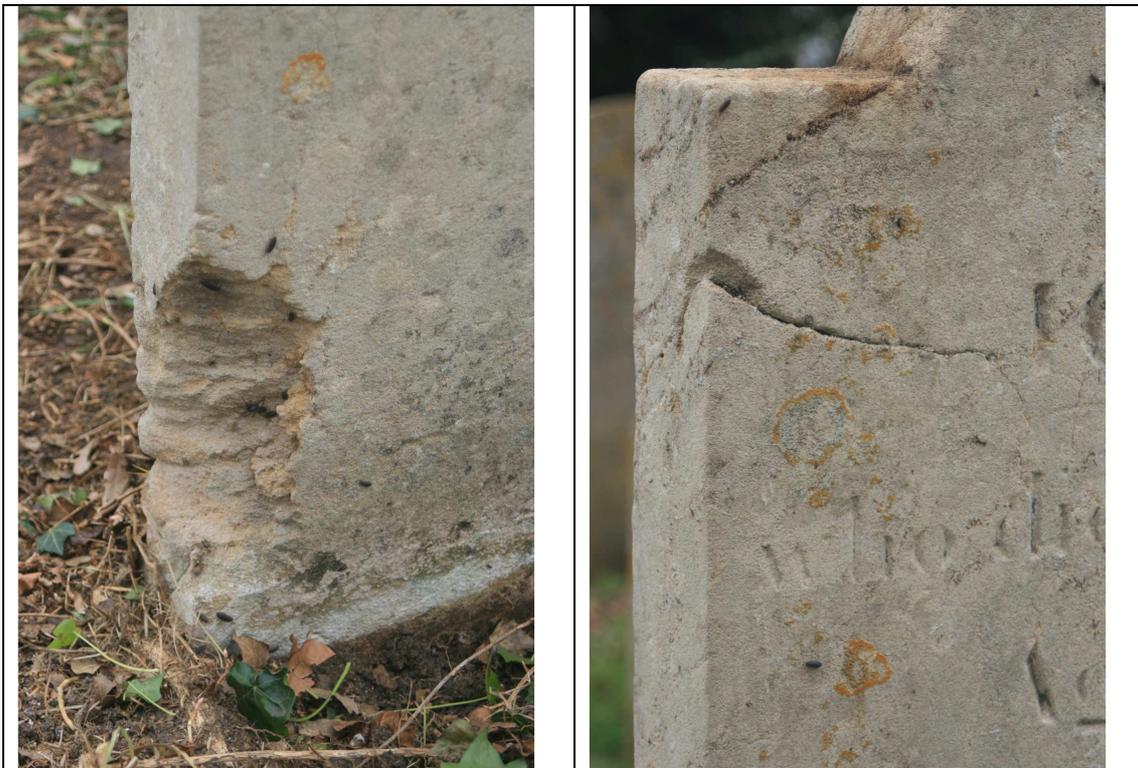
Uncovering already damaged stones (see photographs 13 & 14) might result in increased damage through their exposure to the elements. The Churchyard Authorities are strongly advised to plan for the uncovering of damaged stones and to make the necessary financial provision to cover the costs of any essential repairs.

Photograph 13 & 14 : Exposure of pre-existing defects might open the gravestones up to further damage by the elements

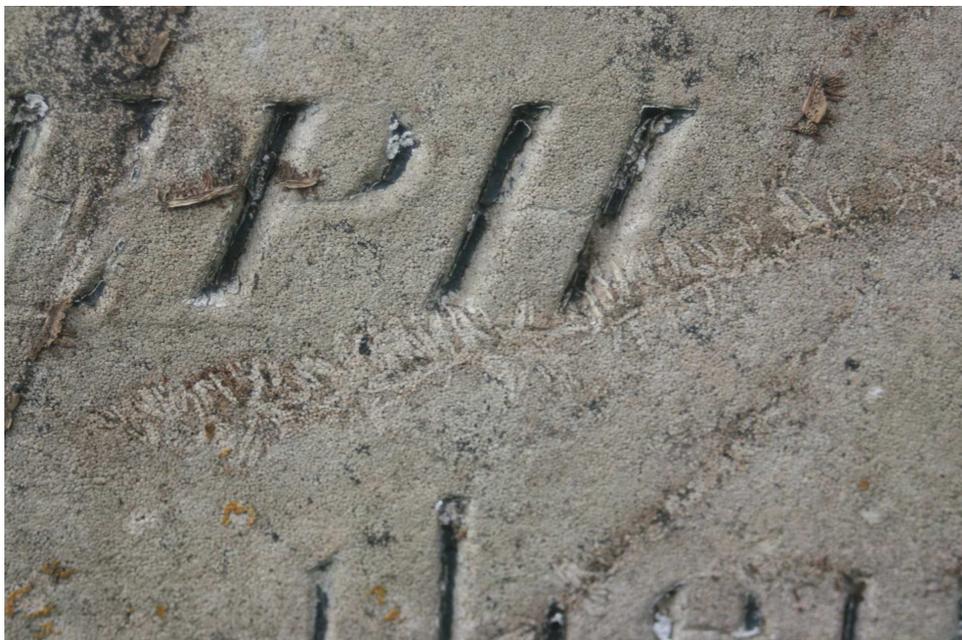
However, in some cases these aerial roots do seem to have left clear marks (see photograph 17 below) these marks are not visibly etched into the stone and may be simply where the aerial roots have covered part of the stone and the surrounding area is dirty.

Photograph 15 : Marks left by some aerial roots

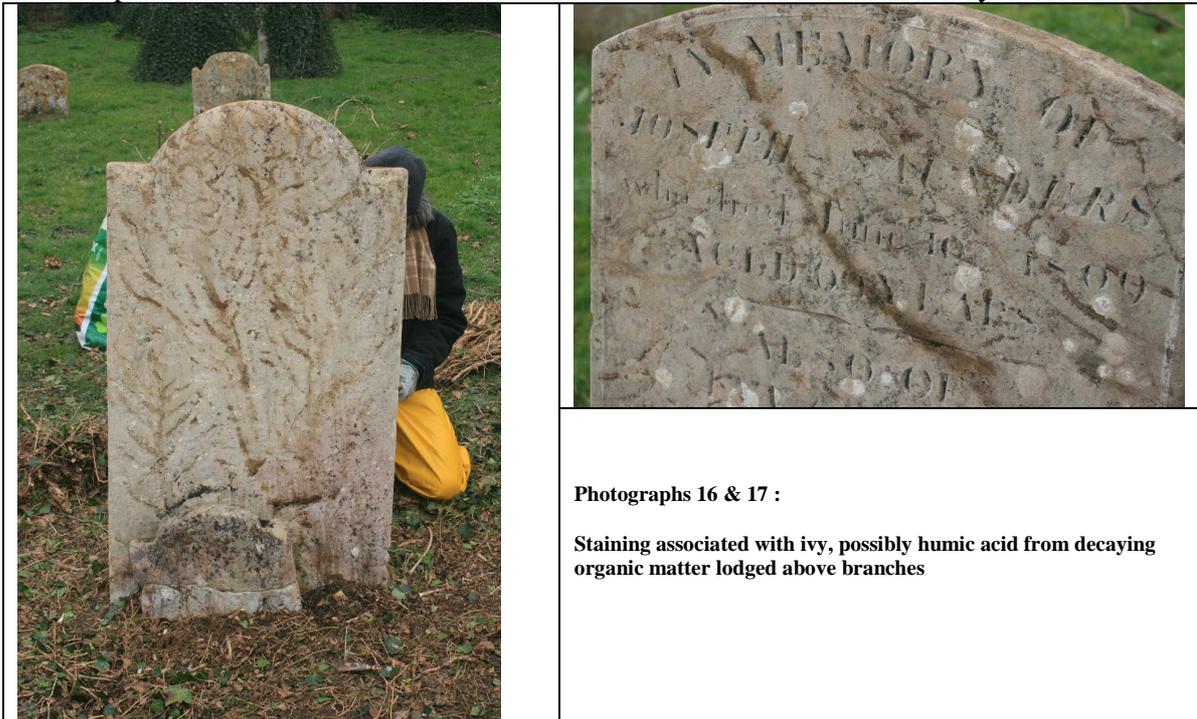
Photographs 16 & 17 :

On two of the stones uncovered there is clear evidence of brown staining directly associated with the branch network. This appeared not to be associated with the ivy stems/branches directly producing materials which stain the stone, but with the accumulation of organic matter above branches which begins to decay and release

humic acid (see photographs 16 & 17 below). This staining may disappear after a time exposed to the elements and this will be monitored over the next few years.

Staining associated with ivy, possibly humic acid from decaying organic matter lodged above branches

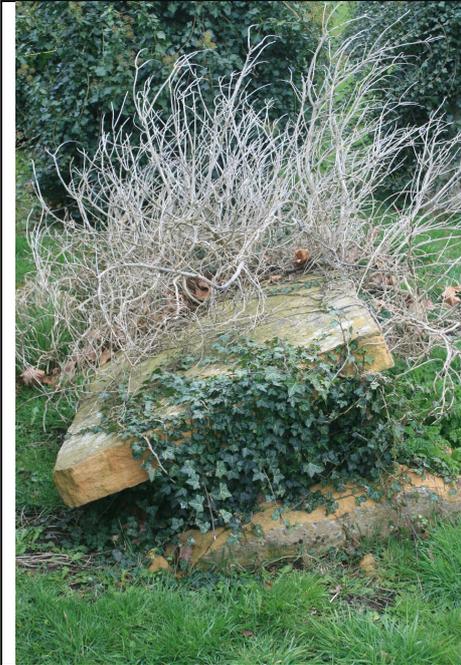
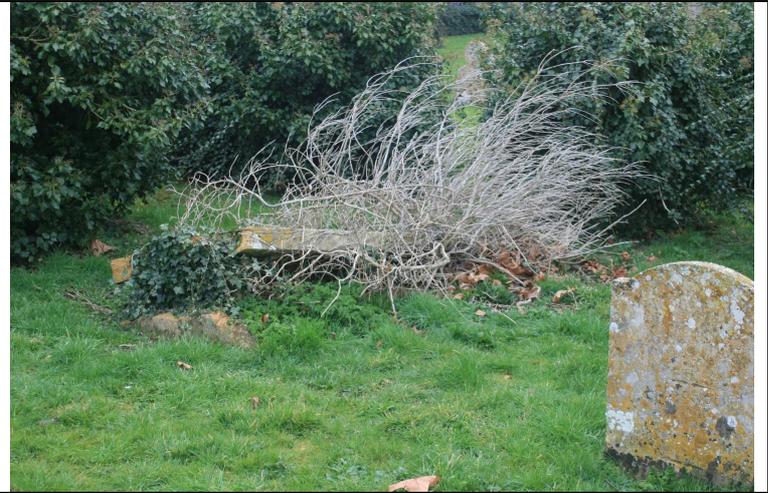
There is only one example of toppled gravestone which was covered in ivy (see photographs 18 & 19 below). Although this appear to be more of a ‘shrub’ type and it is impossible to say if the stone itself had a pre-existing flaw.

Photographs 18 & 19 : The only fallen ivy covered stone
