Ludlow Swift Conservation Group

The Church of St James the Apostle, Wigmore

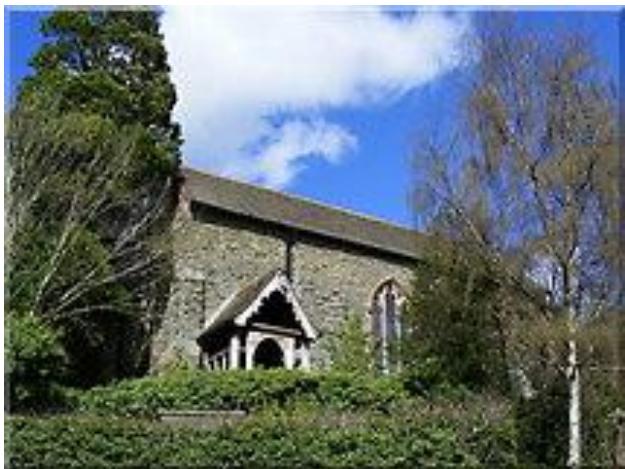
The **eaves in the south wall** of this church – shown in greater detail below – provide excellent access for swifts. The flight path to the high eaves is unobstructed and there is clear evidence that the whole length of this wall is used by swifts.

Picture of the south face of the Church of St James taken from Castle Street.

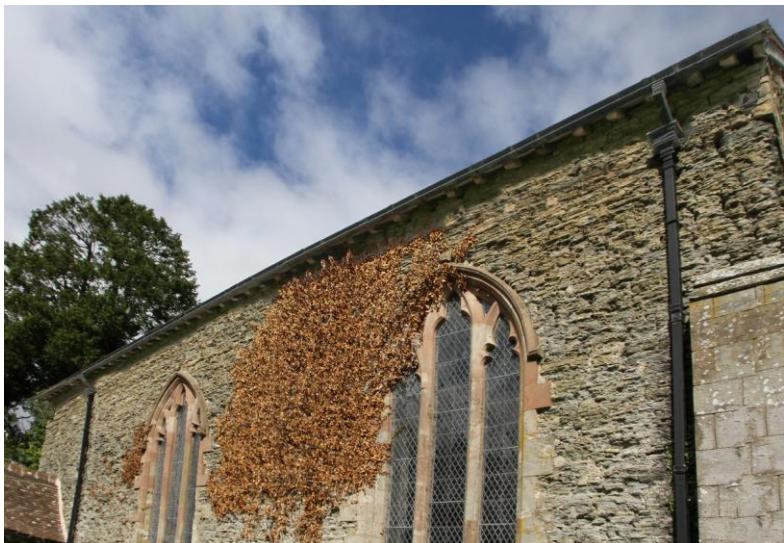
South wall – site of the swift colony.
There is evidence of swift nest sites along the whole length of this wall.

The construction of the south wall is ideal for swifts especially around the emergence of the rafters where there are suitable gaps for the swifts to gain access to nest sites. It is anticipated that the south wall has a broad, flat top and that the birds nest on this wall plate.

- none of the holes along the top 2 courses of stone are filled or the hole sizes altered in any way.
Discussion with one of the architects on 12th September confirmed that the unsealed wall top which is well covered by the eaves is not detrimental to the fabric of the church
- ivy – or any other climbing plant – is kept well clear of the eaves otherwise predators such as mice may use it to access the nests
- any work to the south wall is completed before the arrival of the birds at the end of April or commenced after they have migrated at the start of August
- no scaffolding is placed against the south wall while the swifts are here as this can seriously block access to the nest sites.
- any work to other parts of the church during the breeding season is considerate to these birds who can be disturbed easily.

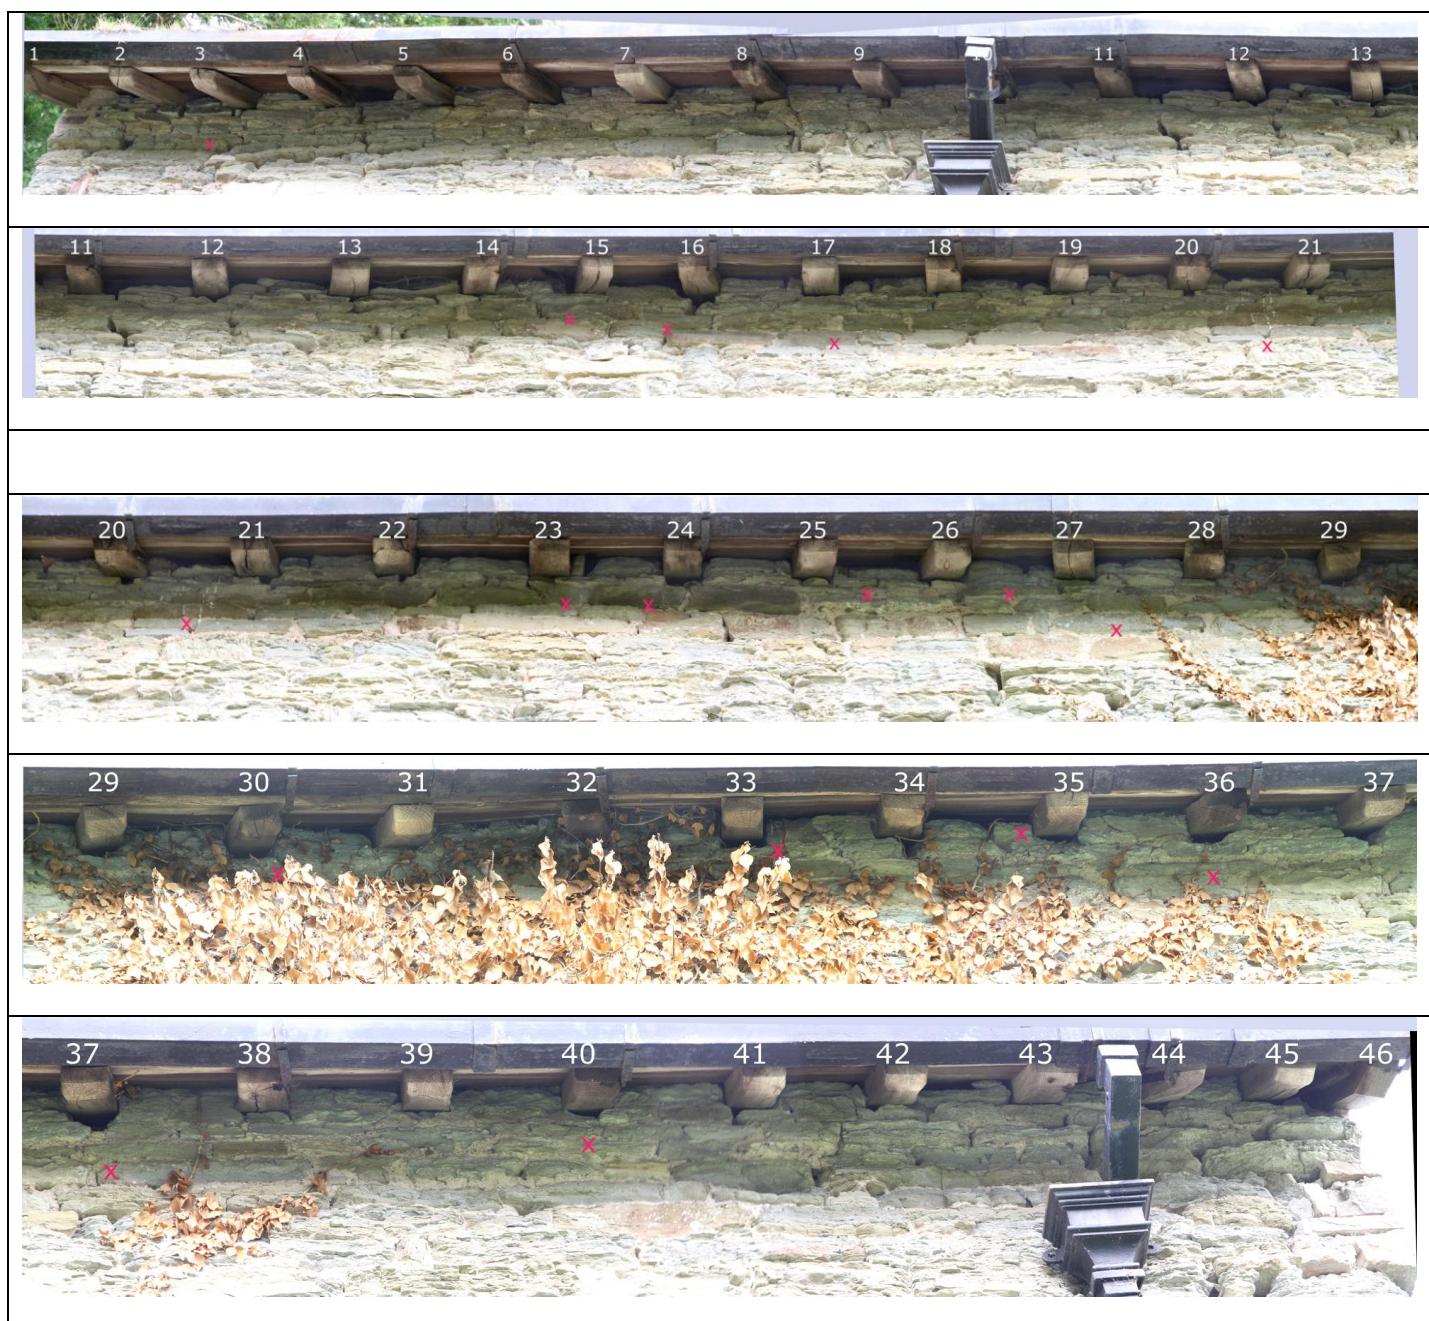
The following series of pictures show the whole span of the south wall moving from west to east. Each rafter end is numbered sequentially and the red crosses indicate the presence of white streaking on the wall. This may not be apparent in the picture but closer inspection has confirmed its presence. A particularly good example of the white streaking can be seen between rafters 20 and 21.

Summary of identified swift nesting sites

By rafters 3, 15, 16, 17, 23, 24, 27, 30, 33, 35, 36, 37, 40

Between rafters 20 and 21, 25 and 26, 26 and 27

It can be seen that near each of the red crosses on the above photographs there are good access points for the birds.

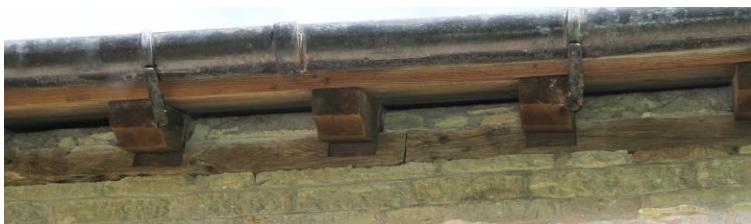
It is noted that previous renovations to the east face of the nave and the south face of the chancel have completely sealed access to the eaves of these parts of the church – perhaps destroying swift nest sites.
